Why We Need to Rethink the Business of Mid-Rise Wood Frame Student Housing

By Derek Hodgin, RBEC, RRO, PE, CDT

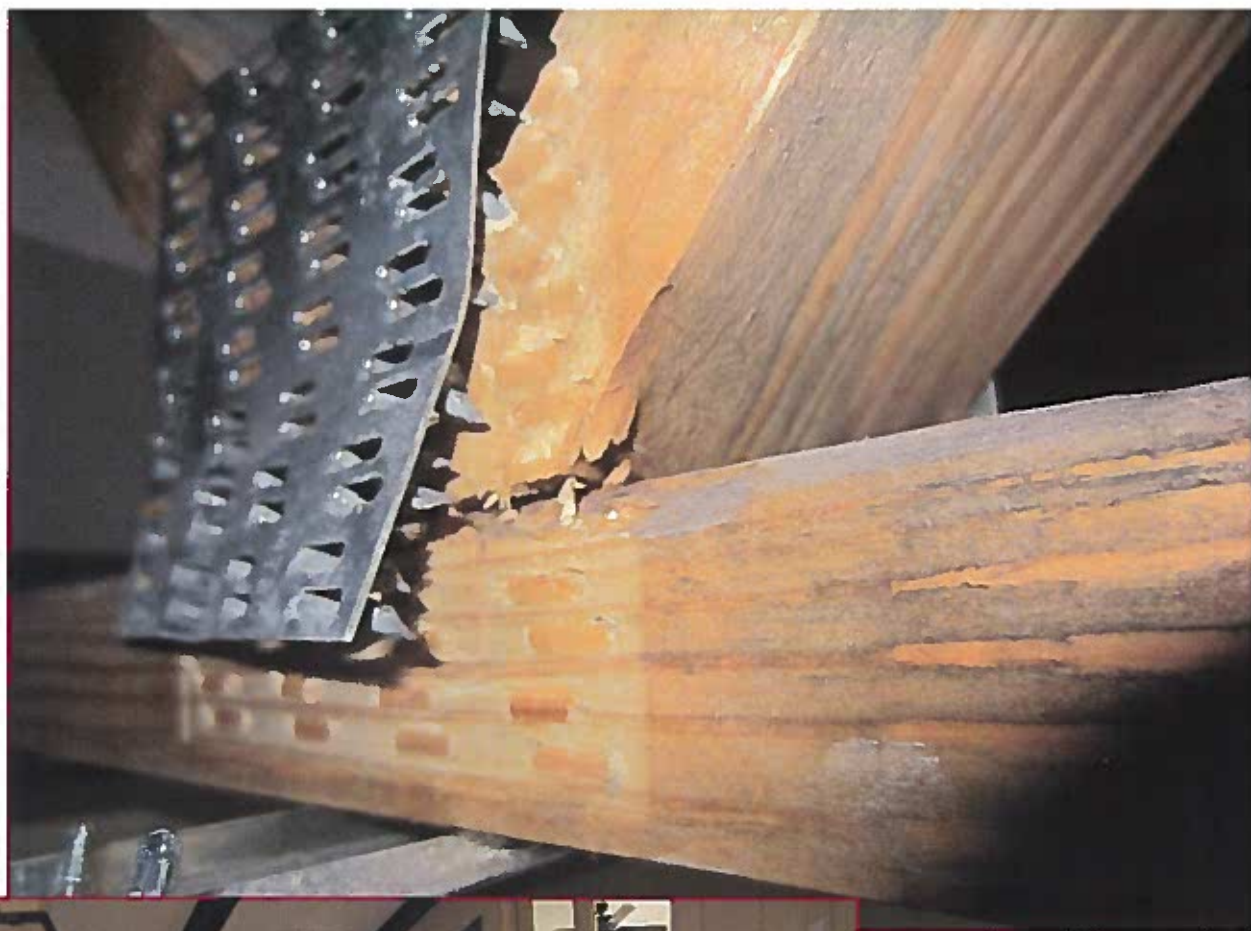
Figure 2 – View of damaged wood truss due to dynamic condition.

buildings. College students have much greater potential of generating dynamic loading conditions on floor framing due to dancing and deciding to “see what happens if we all jump together!” as reported in one of our floor collapse cases (Figure 2).

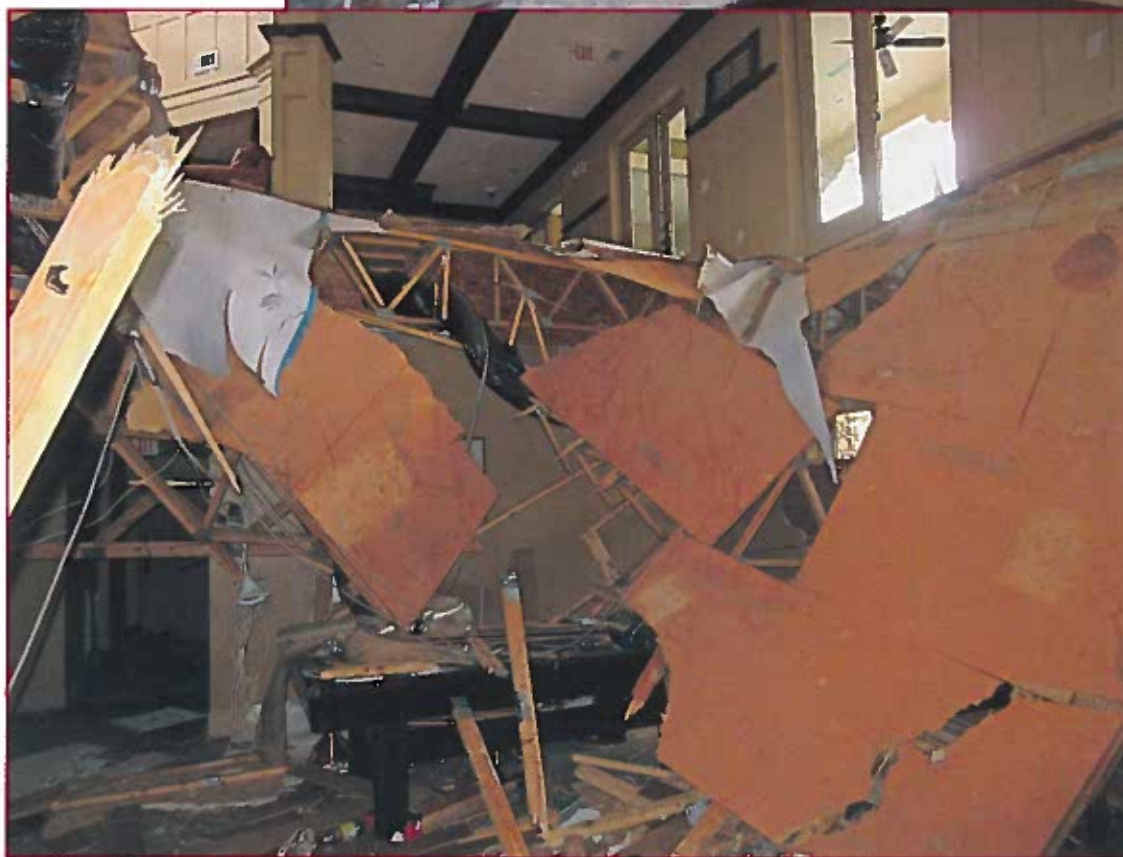
Figure 3 – View of collapsed floor framing.

Our firm has recently consulted on two collapses of wood frame floors and a collapse of a wood frame deck in student-occupied

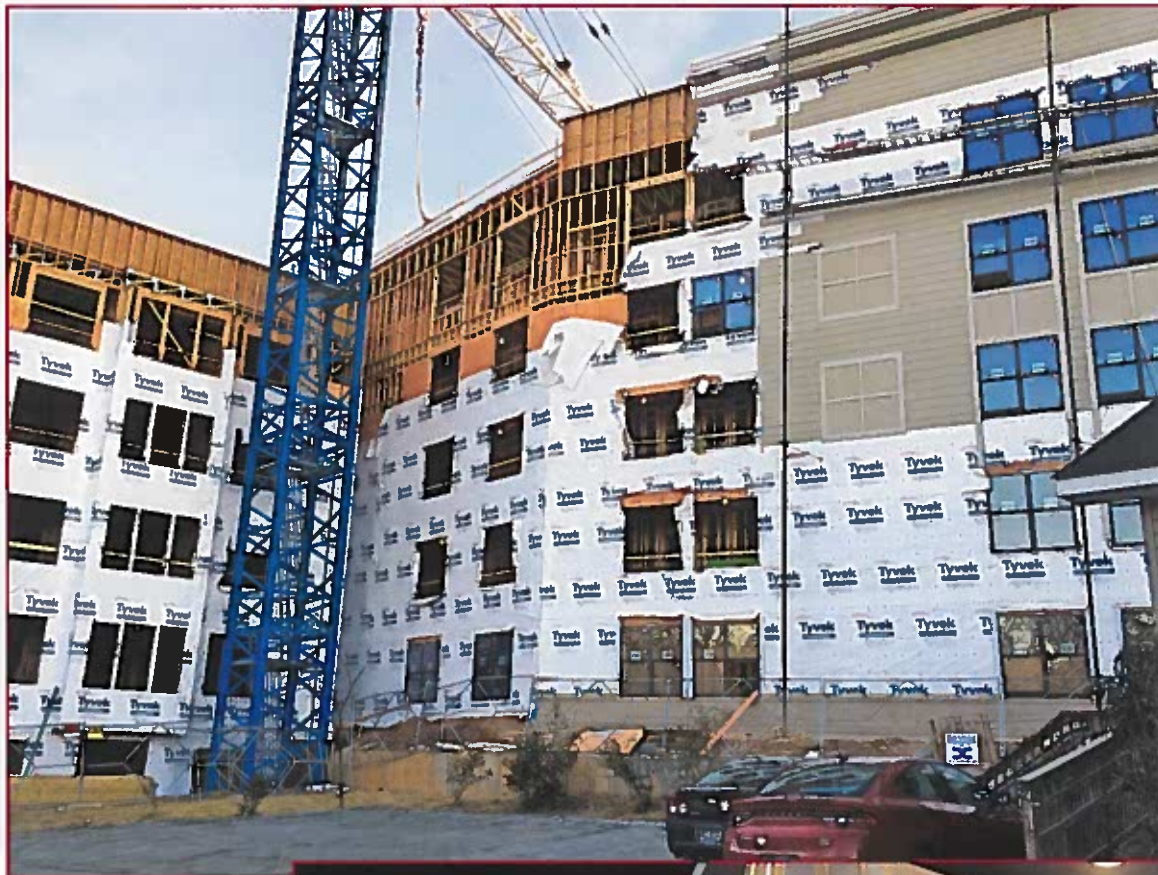
Figure 4 – View of a building in various stages of construction.

Another project trapped water in the exterior wall assembly due to rain events that occurred while the walls were in a variety of stages of completeness. Areas of incomplete weather-resistant barrier (WRB) served to trap and funnel water into the wall assembly, where it remained while the wall construction continued, with no efforts to dry out the wall (Figure 4).

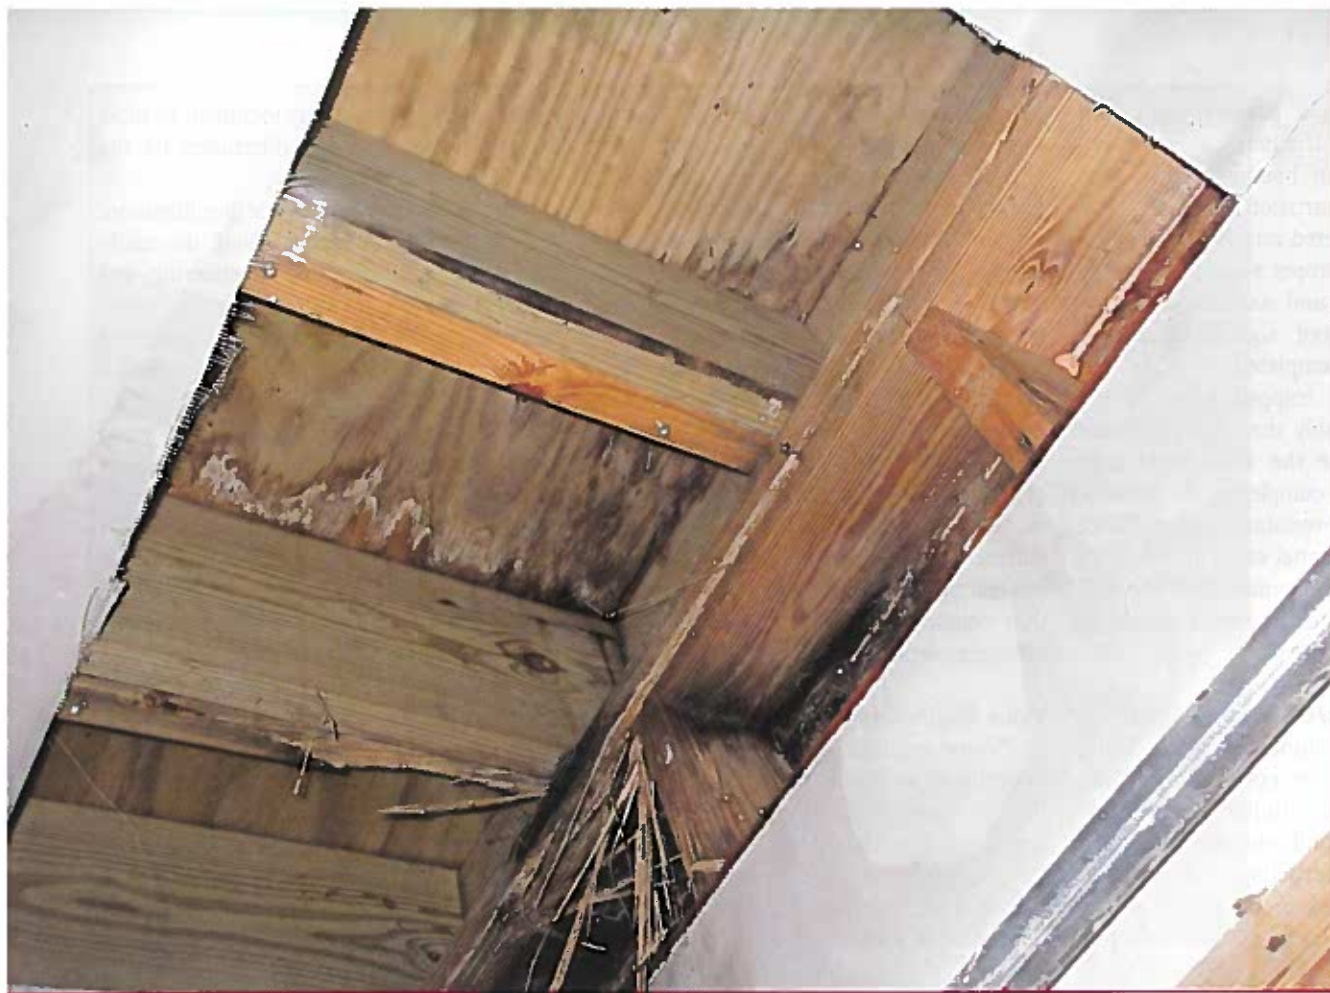
Figure 6 – View of water damage at balcony.

A recent example of a value engineering failure involved balcony waterproofing details. While the project plans depicted a well-known waterproofing system, a decision was made to replace the best-practices waterproofing system with a code-compliant waterproof coating over a flat wood balcony

subfloor and cover the waterproofing with a concrete topping slab. Significant water intrusion and rot were documented within five years after the project was completed. The balcony repairs that are now required will be significant. Fortunately, no one was injured or physically harmed by the resulting damages (*Figure 6*).

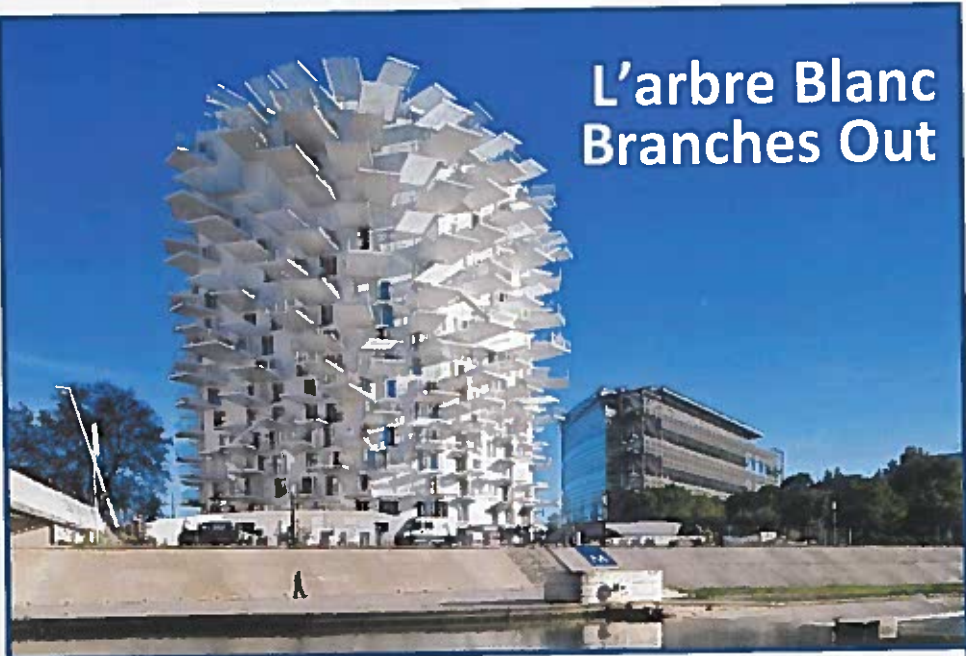
L'arbre Blanc Branches Out

The kidney-shaped building has 113 luxury apartments—many with cantilevered balconies—some as long as 25 feet out from the building and formed of built-up welded sections and bolted to vertical steel H-beams fixed to the concrete floor slabs. Steel pergolas serve as sun-breakers above the balconies.

The reinforced-concrete column-and-slab structure and enclosing walls rely on faceted planes to bend around corners. The building includes a rooftop bar and restaurant, and an art gallery is housed in the base, with coworking office space on the floor above.
